Redevelopment Study & Preliminary Investigation Report

**Block 256, Lot 1; and,
Block 256, Lot 1.01**

**City of Gloucester City
Camden County, New Jersey**

February 28, 2008

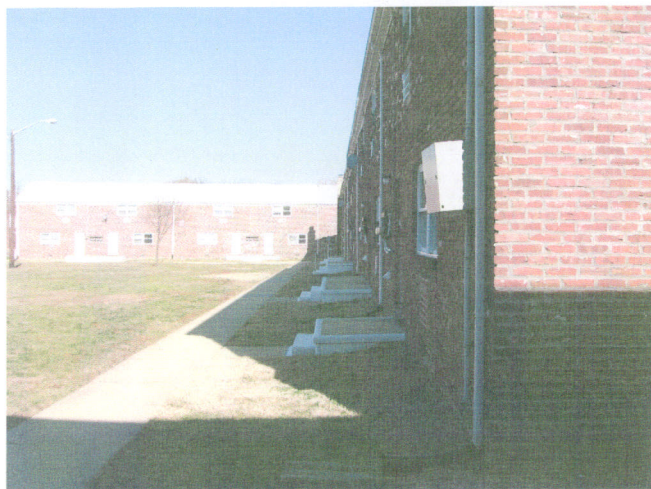
This photograph was taken looking northward from the southern end of Building D.

Pictured to the right are Building D (foreground) and Building C (background). This photograph shows the site's limited landscaping and lack of shade trees, which creates a relatively stark and unwholesome living arrangement. In addition, no recreation facilities are provided onsite.

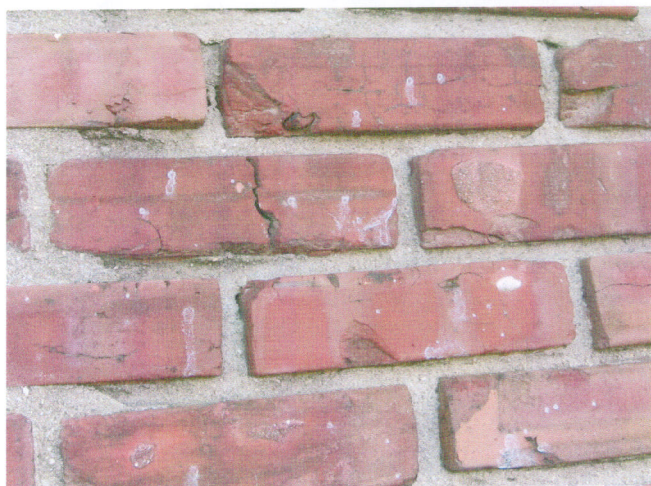
Shown to the right is a detail of the façade of Building A, which is typical of all other buildings on the property.

The façade demonstrates signs of ageing and mechanical weathering of the brick surfaces, which is indicated in the random chipping and cracking shown on the façade.

In many areas, the façade also contains random white stains. This demonstrates a lack of maintenance to the property.

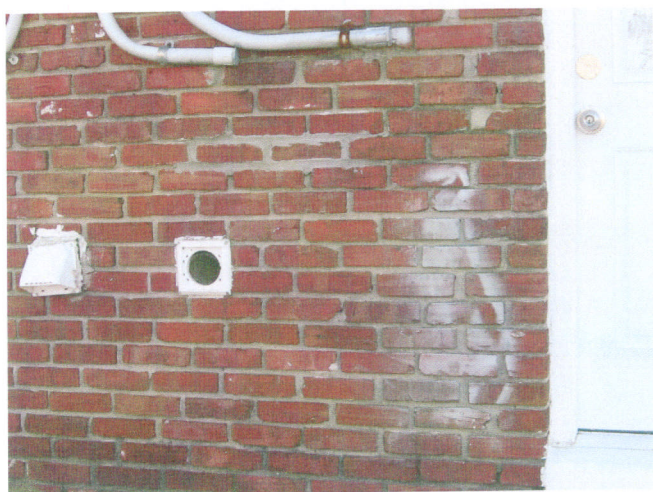
This photograph is of the northern façade of Building A.

The picture to the right demonstrates a lack of proper maintenance to the property, which is evident in the missing dryer vent cover and what appear to be the remains of graffiti on the façade surface.

The lack of a dryer cover on the vent also could create a fire or safety hazard, as it provides access for birds, rodents, and other nesting animals to the dryer hose.

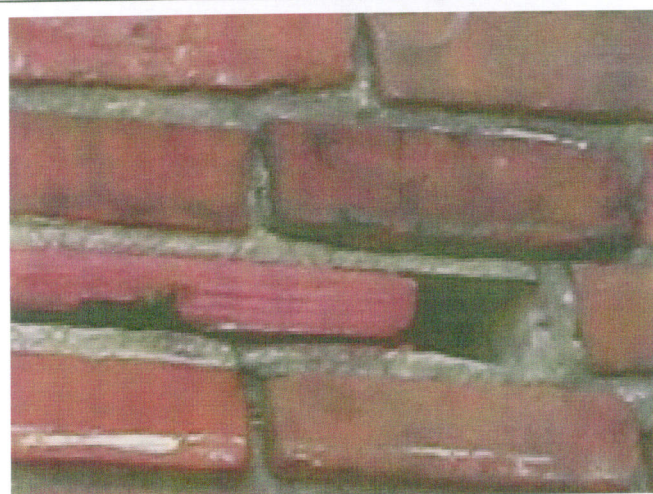
This photograph is of the southern façade of Building F.

The façades of Building E and Building F contain strips of wood sandwiched between, and next to, bricks. The purpose of these strips appears to be as anchors for previous awnings or other architectural elements that are no longer part of the building structure. Note the gaps in the bricks and lack of maintenance.

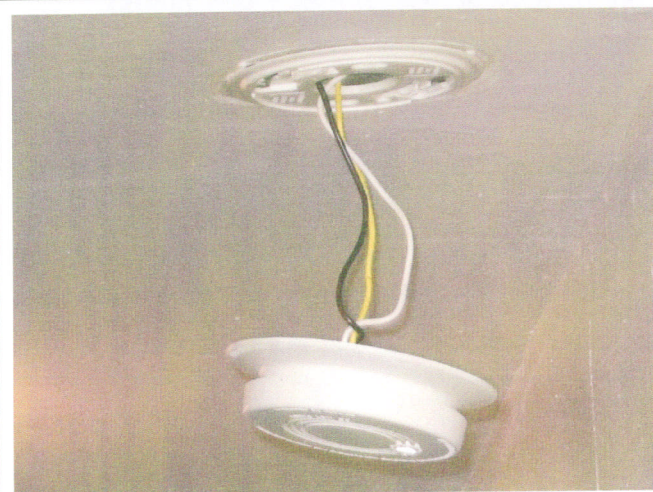
This photograph demonstrates a lack of proper maintenance to the property and existence of a potential life hazard, which is evident in the improperly affixed fire protection device.

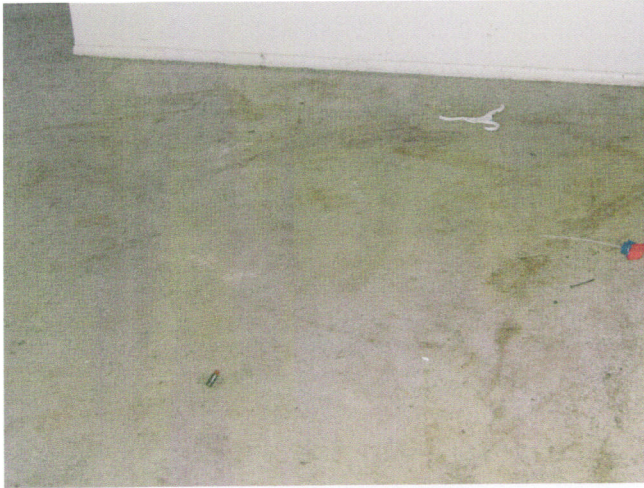
This photograph was taken inside Apartment No. 87, which is located in Building G.

Pictured to the right is the carpeted floor of a bedroom, which is smeared with what appears to be long-dried human feces and other excrements, and littered with various objects.

Access to the unit was unrestricted, as its door was unlocked. Glass from a broken bedroom window suggests that the unit was originally broken into in a forceful manner.

These conditions represent a clear threat to the public health, safety, and welfare, and demonstrate a continued lack of proper maintenance, inadequate security, and unwholesome living conditions.

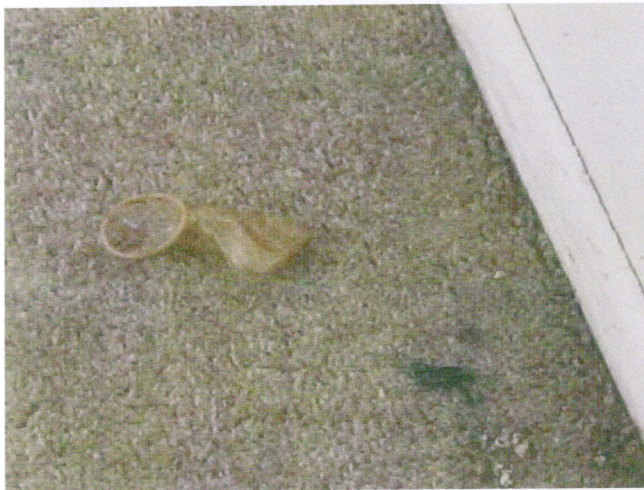
As noted, this photograph was taken inside Apartment No. 87, which is located in Building G.

Pictured to the right is a used prophylactic that was found in the bedroom of Apartment No. 87.

This picture further solidifies the claim that the conditions found within Apartment No. 87 represent a clear threat to the public health, safety, and welfare, in addition to demonstrating a continued lack of proper maintenance, inadequate security, and the creation of unwholesome living conditions.

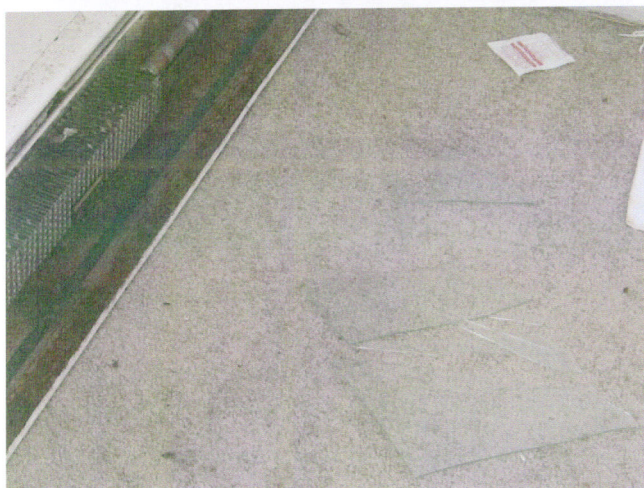
Shown to the right is the glass of a broken window in Apartment No. 87. The photograph also shows an uncovered baseboard heater and what appears to be mold on the top surface of the heater and lower portion of the wall.

This picture further supports the finding that the conditions found within Apartment No. 87 represent a clear threat to the public health, safety, and welfare, in addition to demonstrating a continued lack of proper maintenance, inadequate security, and the creation of unwholesome living conditions.

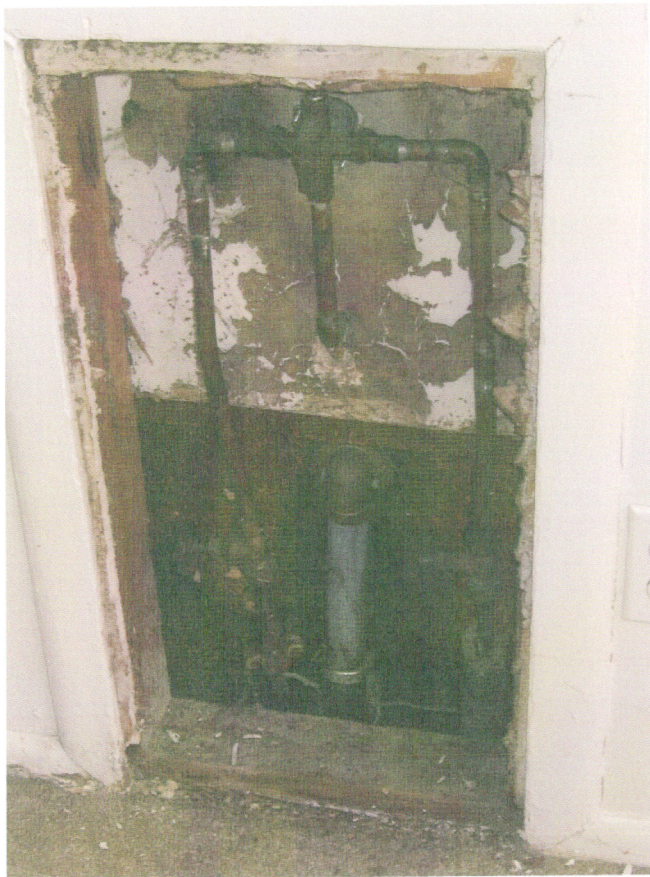
This photograph was taken inside Apartment No. 87, which is located in Building G.

This picture shows the removed access panel to the bathtub plumbing fixtures of Apartment No. 87. As shown near the top of the picture, there appears to be some growth of mold in and around the enclosure.

This picture further supports the claim that the conditions found within the complex demonstrate a threat to the public health, safety, and welfare, as well as a continued lack of proper maintenance.

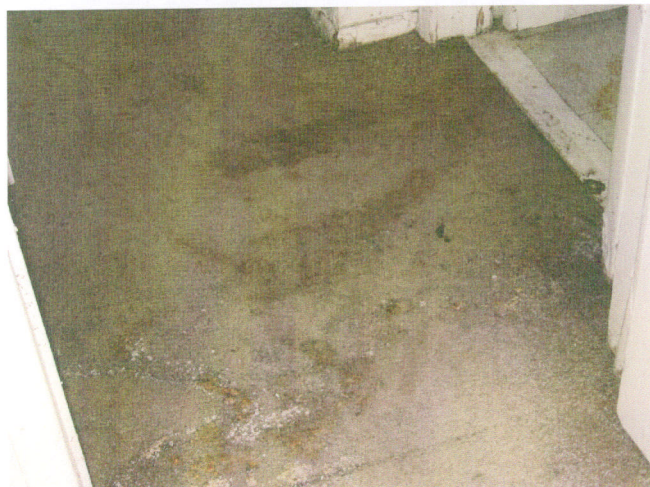
Pictured to the right is the carpeted floor of the hallway of Apartment No. 87, which is smeared with what appears to be long-dried human feces, vomit, and other excrements.

These conditions further solidifies the claim that the conditions in Apartment No. 87 represent a clear threat to the public health, safety, and welfare, and demonstrate a continued lack of proper maintenance, inadequate security, and unwholesome living conditions.

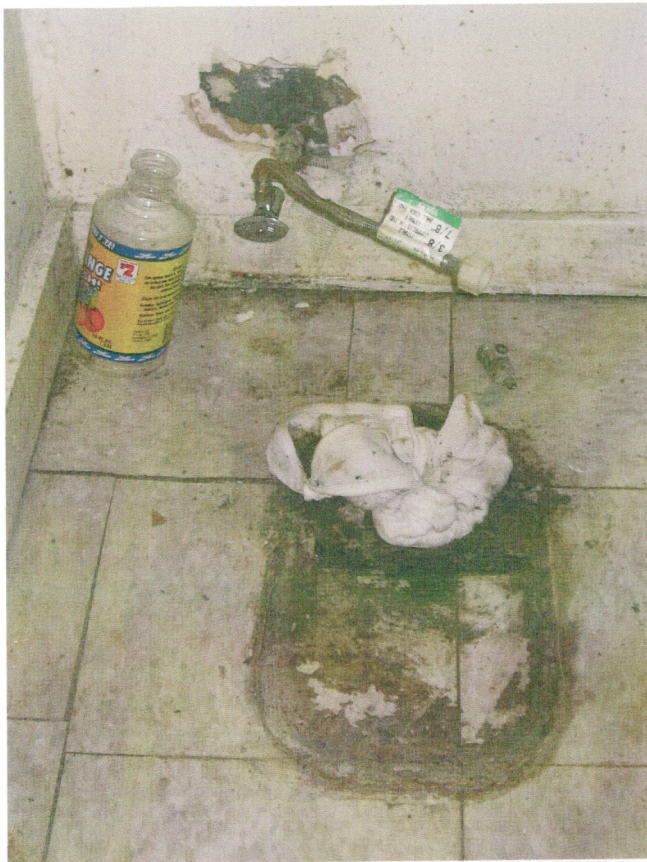
This photograph was taken inside Apartment No. 87, which is located in Building G.

This photograph shows that the toilet has been removed from the Apartment No. 87. There appears to be a significant amount of mold in the area it used to occupy. Additionally, the flexible water supply pipe is rusted and the sheetrock around its entry to the wall is severely damaged.

The presence of these conditions demonstrates a continued lack of property maintenance and sanitation, and a health and safety hazard.

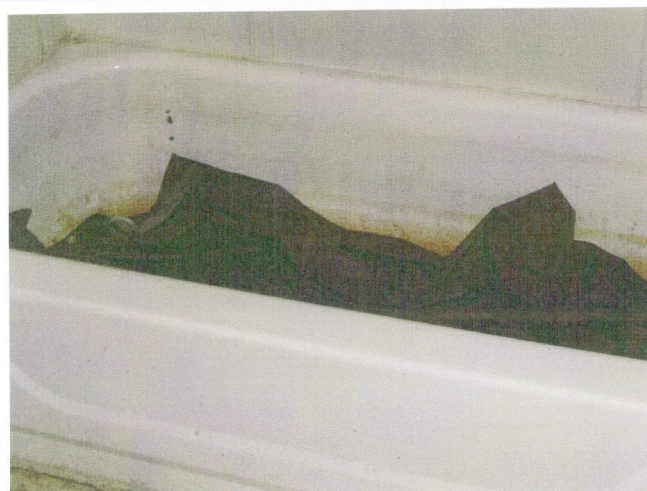
This photograph shows a significant amount of mold and mildew around the tub area, as well as rust and garbage within the tub.

The presence of these conditions demonstrates a continued lack of property maintenance and sanitation, and a health and safety hazard.

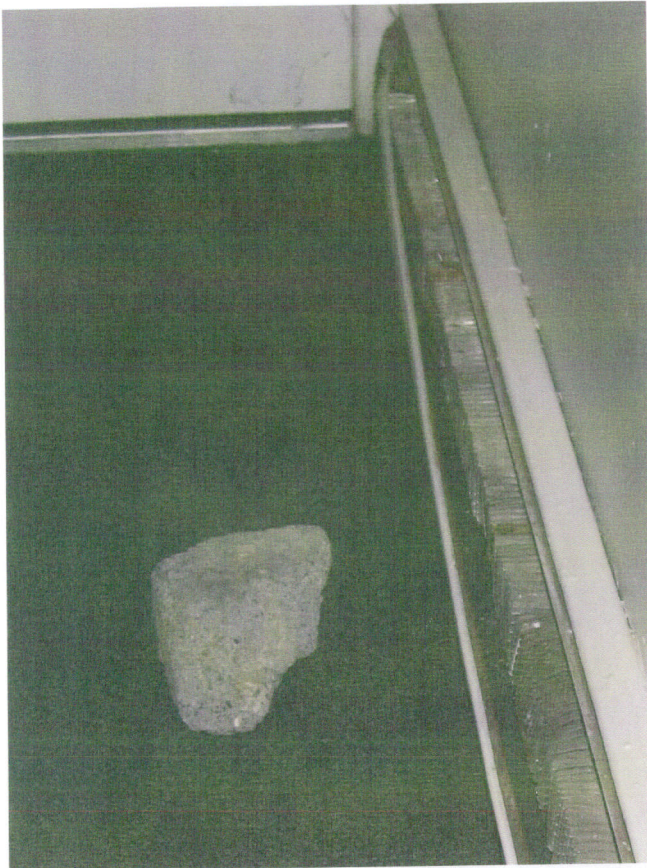
This picture was taken in a common area of Building G.

Shown to the right is a baseboard heater that is in disrepair with its cover improperly affixed and deformed.

This condition signifies a lack of proper maintenance to the property.

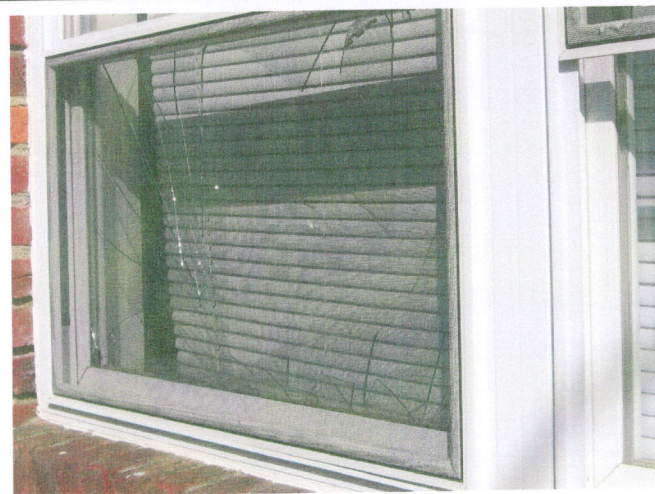
Several broken windows were observed onsite. This is an example from the ground floor of Building G.

The presence of such conditions illustrates the fact that many units in this largely vacant apartment complex are not secure. This creates an attractive nuisance, which results in the potential for criminal mischief and other crime, in addition to health and safety risks.

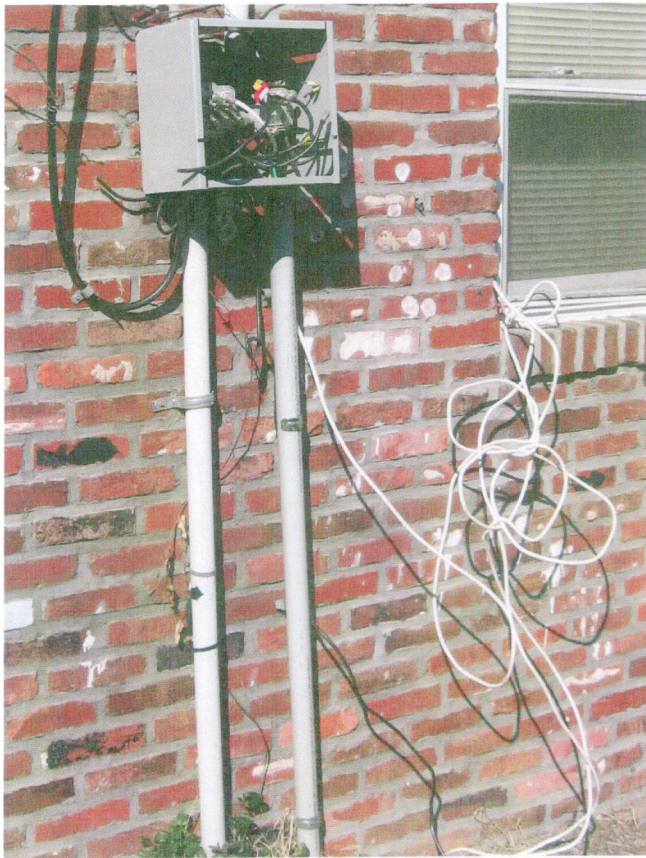
This photograph was taken at the rear of Building H.

The pictured utility box houses television cable lines and related equipment. Upon inspection of the site, the box was open and its contents were exposed to the elements. This creates a potential safety hazard.

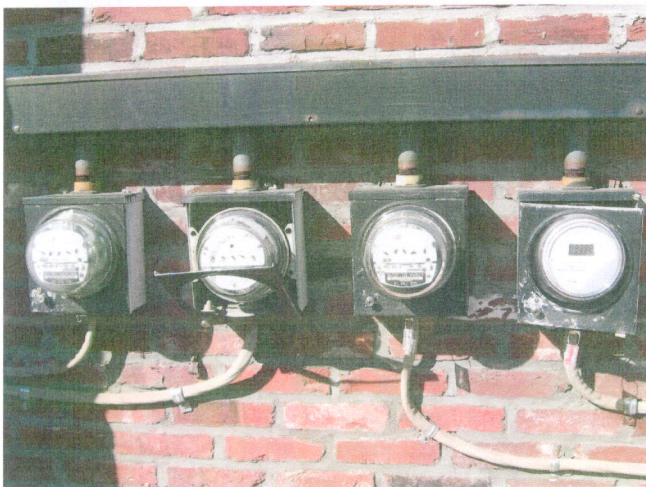
Several electricity meters had been tampered with in an effort to provide un-metered electrical power to occupied units. This constitutes criminal activity.

Unit cases were left open and exposed to the elements. This creates a life hazard due to the risk of high power electric shock.

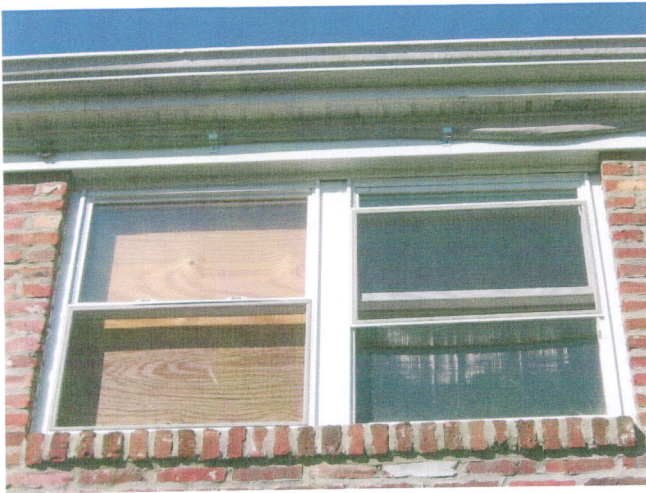
These photographs were taken at the rear of Building H.

Several missing windows were observed onsite. This presents a security issue and worsens potentially deteriorating conditions by inadequately shielding the units from the elements.

In addition, as shown on the right, electrical cables are often not securely fastened to the building façades. This is evident by the casting of shadows from the cable onto the façade. This presents a potential life hazard.

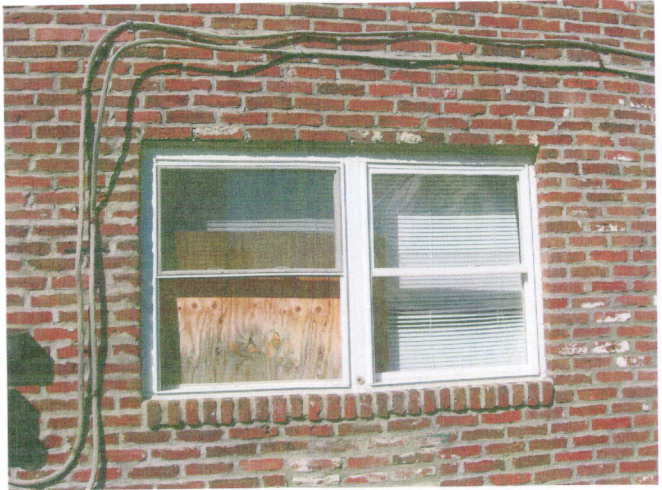
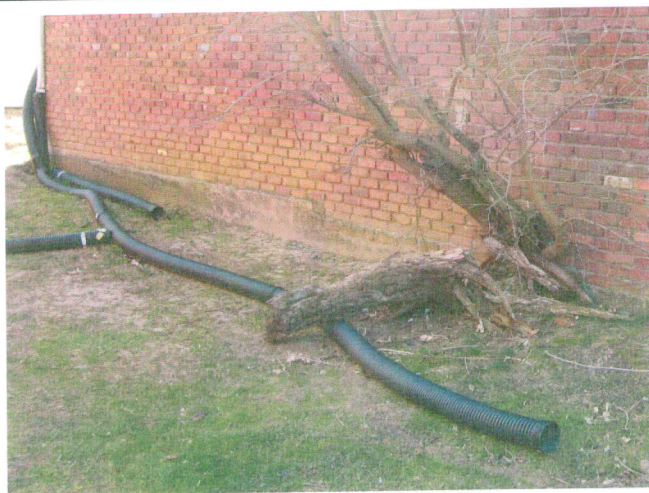
As shown to the right, a tree was observed growing out of the foundation of Building H. This presents a hazard to the structural integrity of the building.

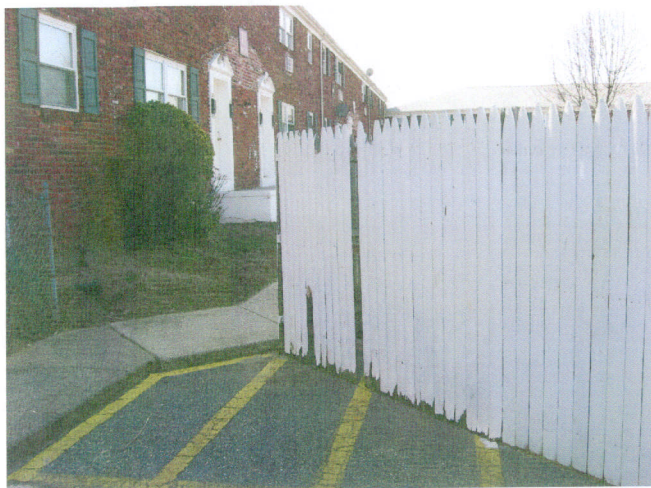
This photograph was taken outside Building H. It is noted that a trash enclosure is similarly placed outside Building C.

Featured in the photograph to the right is the rear of a trash enclosure. The photograph demonstrates dilapidation and a lack of proper maintenance, which is evident in the condition of the fencing. Also of particular concern is its location within very close proximity to the windows of a nearby apartment; this creates the potential for unwholesome living conditions.

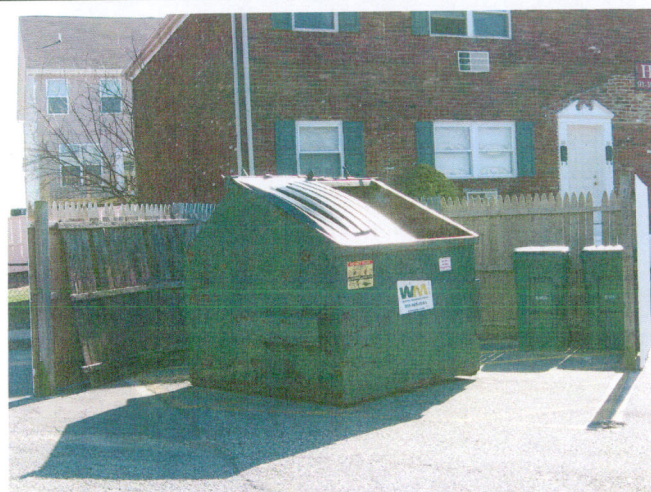
This photograph was taken outside Building H. It is noted that the other trash enclosures located onsite are frequently in a similar condition.

As evidenced by the displaced fence panel that is located behind the dumpster, this photograph further demonstrates dilapidation and a lack of proper maintenance to the property. It appears that the fence panel was once located on the right side of the enclosure, which is suggested by the presence of what appears to be a broken fence post in the bottom-right corner of the photograph.

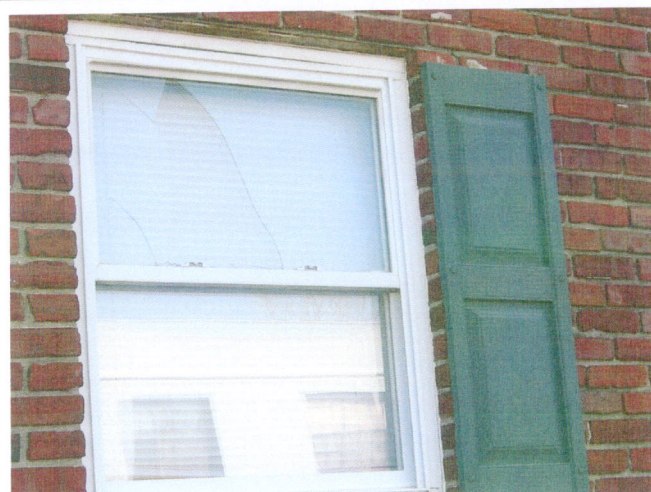
As shown to the right, this photograph demonstrates a lack of proper maintenance and dilapidation. This is evident not only in the broken window, but also in the missing, left-hand shutter.

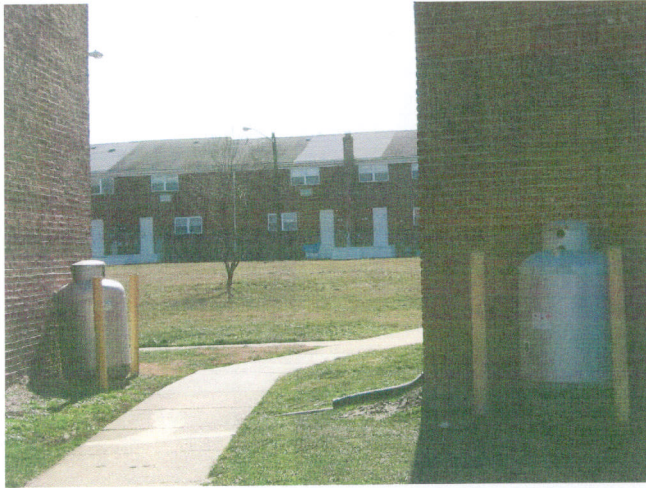
This photograph was taken between Building B and Building C. Similarly placed gas tanks are located in various places throughout the site.

The gas tanks pictured to the right are not located within a proper enclosure. As demonstrated above, utility equipment located onsite has been tampered with in past. As such, it is noted that the location of these gas tanks outside of a proper enclosure creates an attractive nuisance and life hazard.

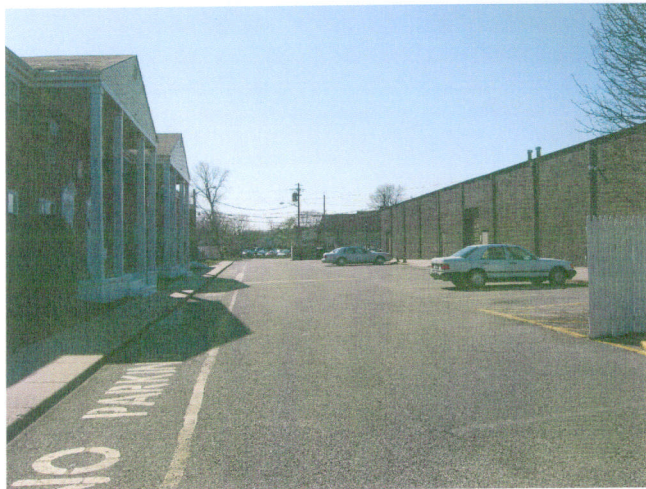
This photograph demonstrates a faulty design and land use arrangement that exists between Block 256, Lot 1 and adjacent Block 256, Lot 4. It is noted that the front of the building and entrance into the residential apartments are located directly behind the rear loading area of a commercial building.

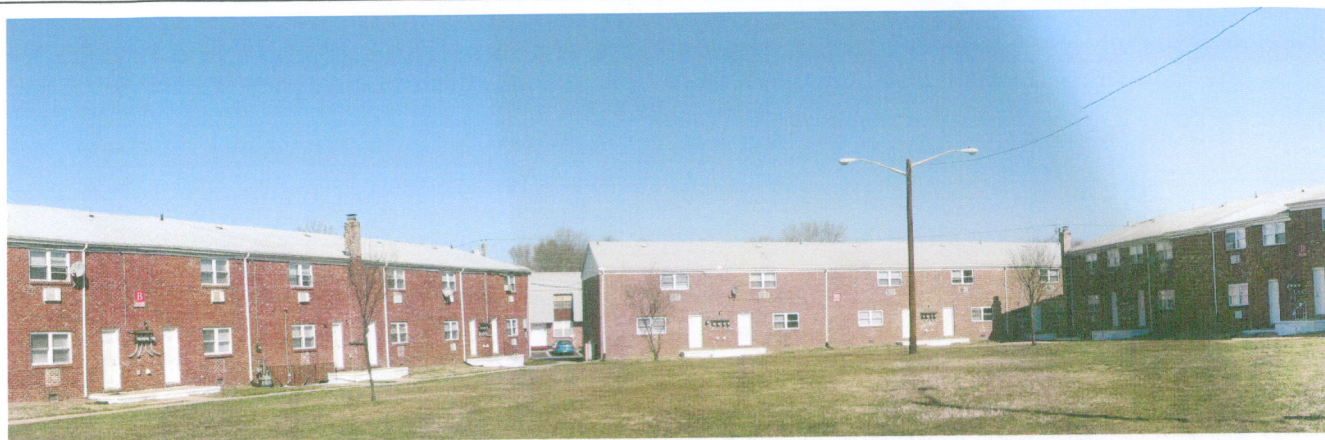
This image shows the open space area that exists between Building A, Building B, Building C, and Building D. The image provides a general overview of the conditions within this area, and illustrates a lack of adequate landscaping and shade trees within the area as well as the generally stark, barrack-like institutional quality of the living conditions. No recreation facilities are located on-site.

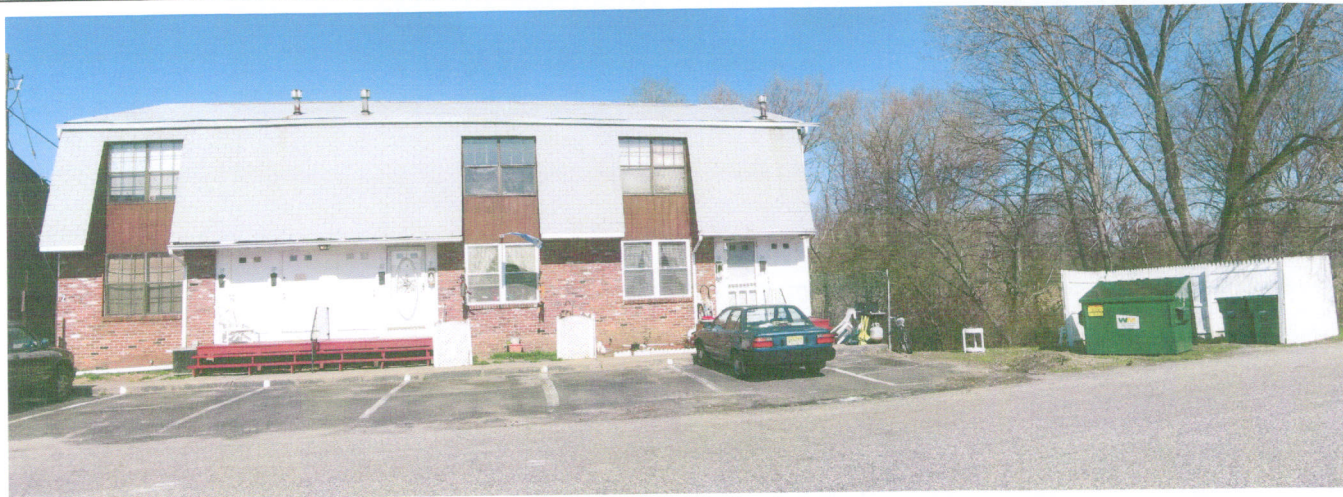
Pictured above is an overall representation of typical building conditions at Gloucester Terrace. The lack of sufficient front yard space is particularly evident in this photograph. The presence of this condition, and the effective lack of a rear yard, suggests a faulty arrangement and design when viewed within the context of Gloucester City's prevailing development patterns.

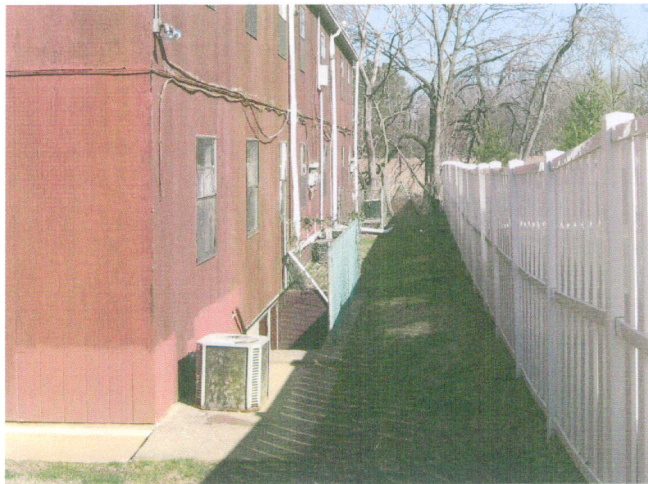
This photograph was taken at the rear of Building 3, which contains Apartment 43 through Apartment 50.

Shown to the right is the rear of the easternmost building of Gloucester Terrace, which houses eight (8) apartments.

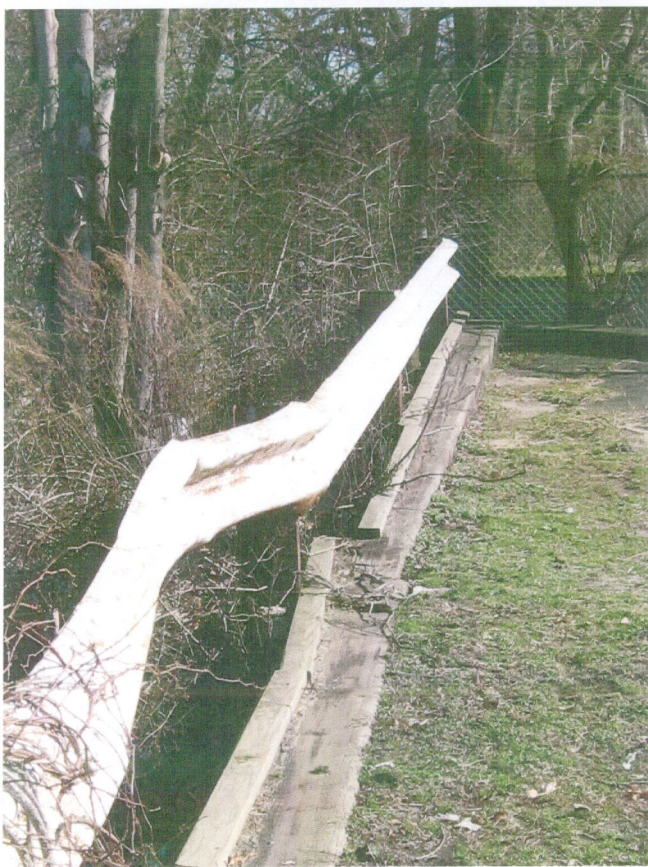
Shown to the right is a dilapidated guard rail and wooden retaining wall that is located at the property's northern boundary. The presence of these conditions demonstrates a lack of adequate maintenance and dilapidated conditions onsite, which may result in threats to the public health, safety, and welfare.

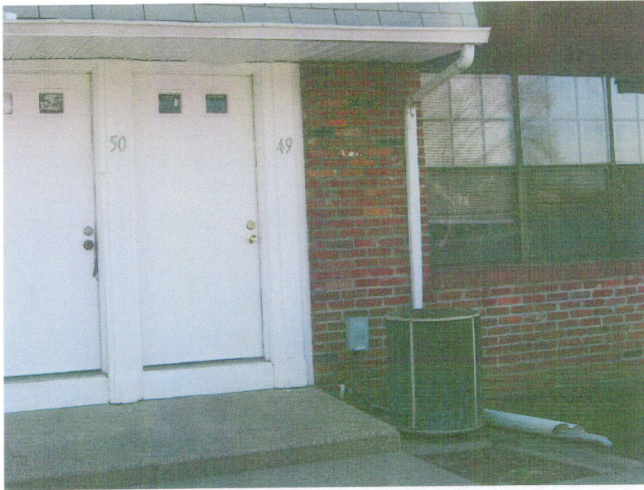
This photograph shows the entrance area of two apartments. As can be seen, the rain gutter shows some flexing and the downspout shows some breakage. This demonstrates a lack of adequate maintenance.

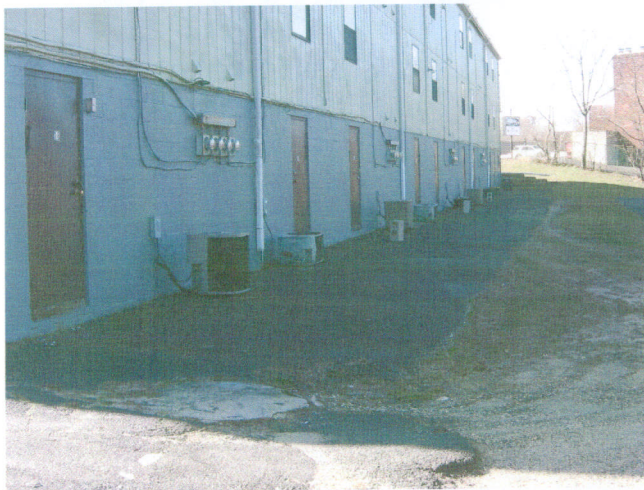
The blacktop shown to the right is in poor condition where it meets the grass- and dirt-covered surface of the remaining areas of the parcel. Also, at least one downspout appears to empty rainwater directly onto the blacktop; this creates potential icing conditions. The presence of these conditions demonstrates a lack of adequate maintenance, as well as a potential threat to the public health, safety, and welfare.

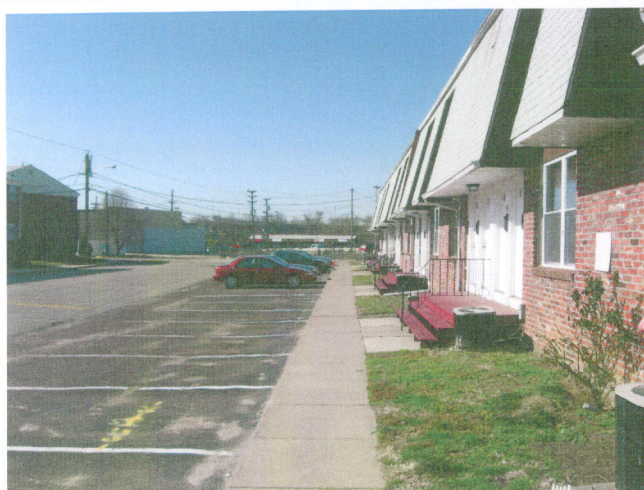
Shown to the right is a westerly view of the southern façade of Building 1 in Gloucester Terrace. This photograph shows a lack of adequate maintenance to the site, which, from this perspective, is immediately evident in the quality of the pavement that covers the parking areas.

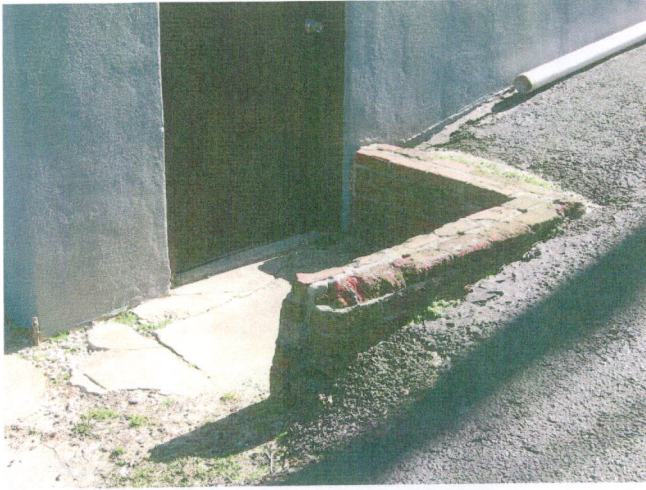
Shown to the right is a basement entrance that is located near the end of a slope that runs between Building 1 and Building 2 in Gloucester Terrace. The area is surrounded by a retaining wall that does not include a railing or similar safety feature. It is also noted that the pavement is in poor condition, which is demonstrated by cracking, chipping, and uneven surfaces. Additionally, the drainage downspout is not connected to a proper disposal system, which results in the potential for pooling of water and icing conditions near the entrance.

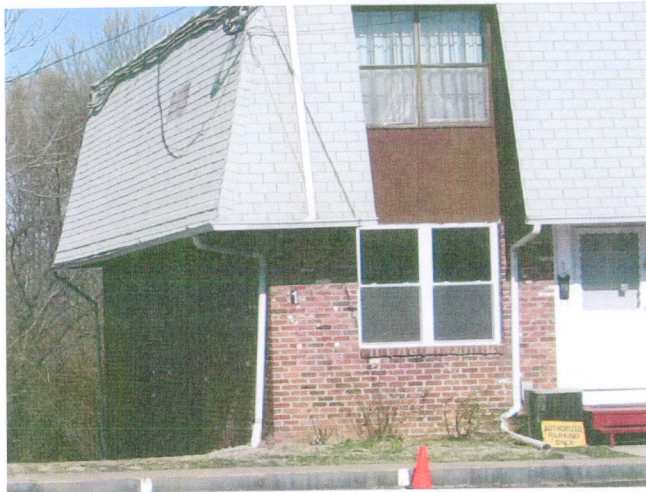
This photograph shows improperly affixed rain gutter downspouts. It also shows flexing of gutters, and the location of a central air conditioning unit near the front entrance of Apartment 1, as well as an improperly affixed electrical or similar cable on the eastern façade of Building 1. These conditions demonstrate a lack of adequate maintenance and early signs of dilapidation, which, if conditions worsen, may present hazards to the public health, safety, and welfare.

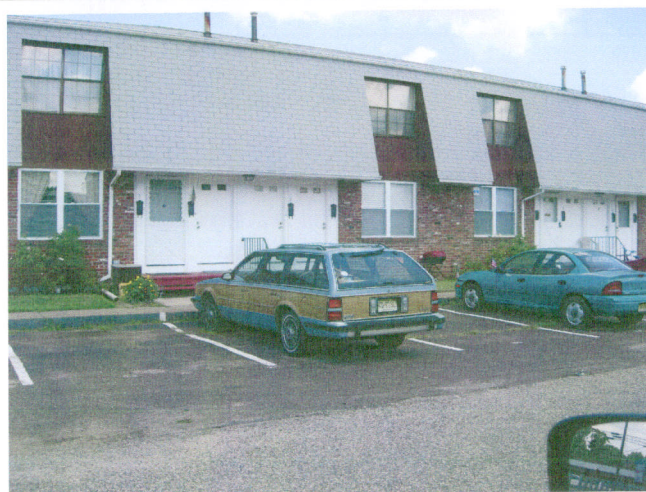
This photograph further corroborates claims of a lack of sufficient maintenance to the property. This is evident in the rusted exhaust pipes extending from the roof, as well as the condition of the pavement.

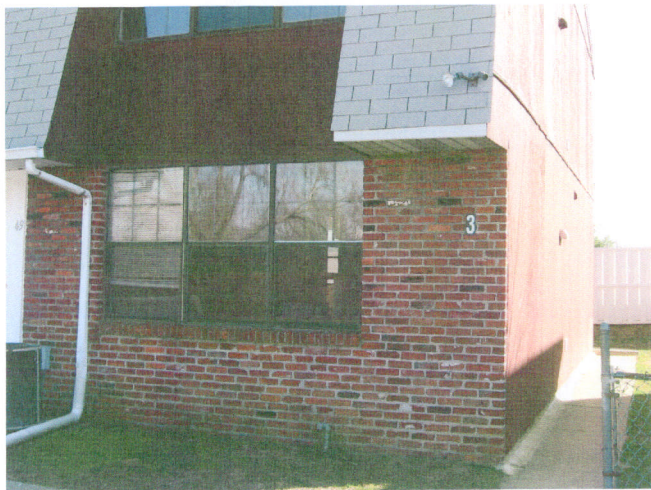
This photograph further corroborates claims of a lack of sufficient maintenance to the property. This is evident in the missing light bulb on the fixture located at the corner of the building.

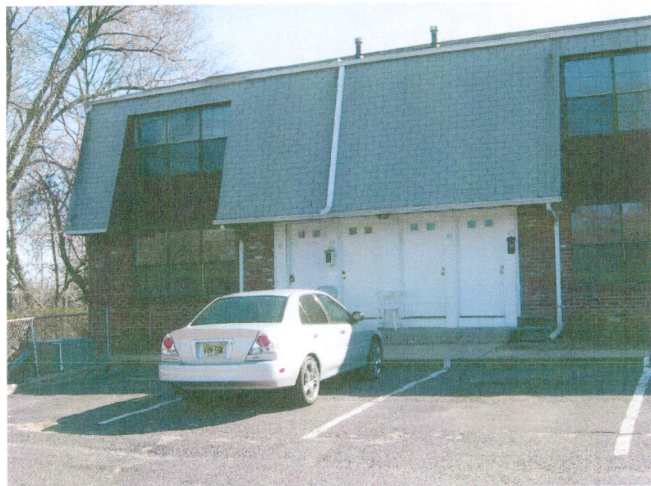
This photograph further corroborates claims of a lack of sufficient maintenance to the property. This is evident in the stained shingles, as well as the condition of the pavement.
